## **ROTOR FAULTS DETECTION IN SQUIRREL-CAGE INDUCTION MOTORS BY CURRENT SIGNATURE ANALYSIS**

**Abstract:** The condition monitoring of the electrical machines can significantly reduce the costs of maintenance by allowing the early detection of faults, which could be expensive to repair. In this paper some results on non-invasive detection of broken rotor bars in squirrel-cage induction motors are presented. The applied method is the so-called motor current signature analysis (MCSA) which utilises the results of spectral analysis of the stator current. The diagnosis procedure was performed by using virtual instruments (VIs). The significant presence of some well-defined sideband frequencies in the harmonic spectrum of the measured line current clearly indicates the rotor faults of the induction machine. The theoretical basis of this method was proved by laboratory tests.

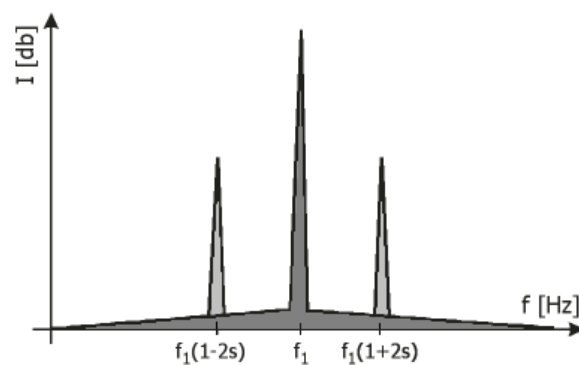
**Figure 2 – Idealised current spectrum**

An idealised current spectrum is shown in Fig. 2. The two slip frequency sidebands due to broken rotor bars near the main harmonic can be clearly observed.

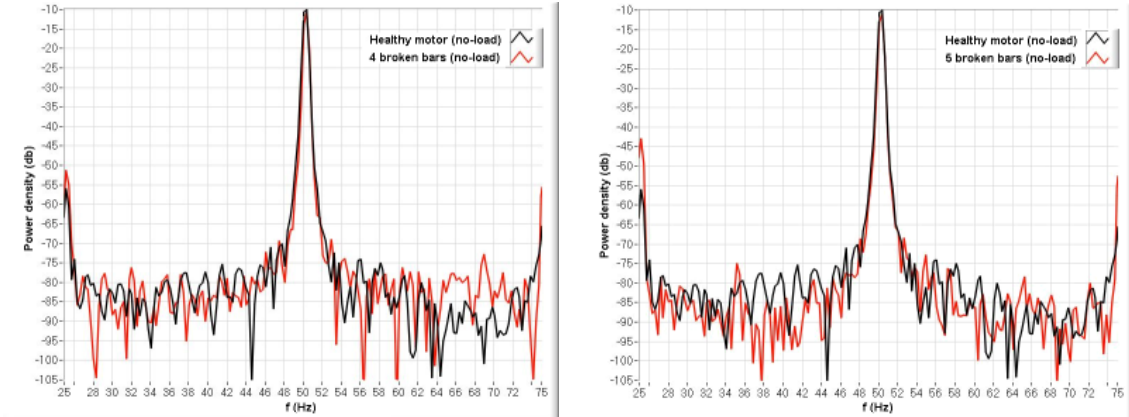
**Figure 5 – The power density of the measured line current at no-load**

From the huge number of obtained results here only the most significant ones will be presented. The power densities of the measured line current at no-load for 3 conditions of the studied motor are given in Fig. 5.

**a) healthy and 4 broken bars motor**

**b) healthy and 5 broken bars motor**

As it can be seen from the figure, the detection of the searched slip frequency sidebands at no-load (and also at little loads) is too difficult, since the current in the rotor bars is small. The most eloquent results were obtained at great loads, especially near the rated load.

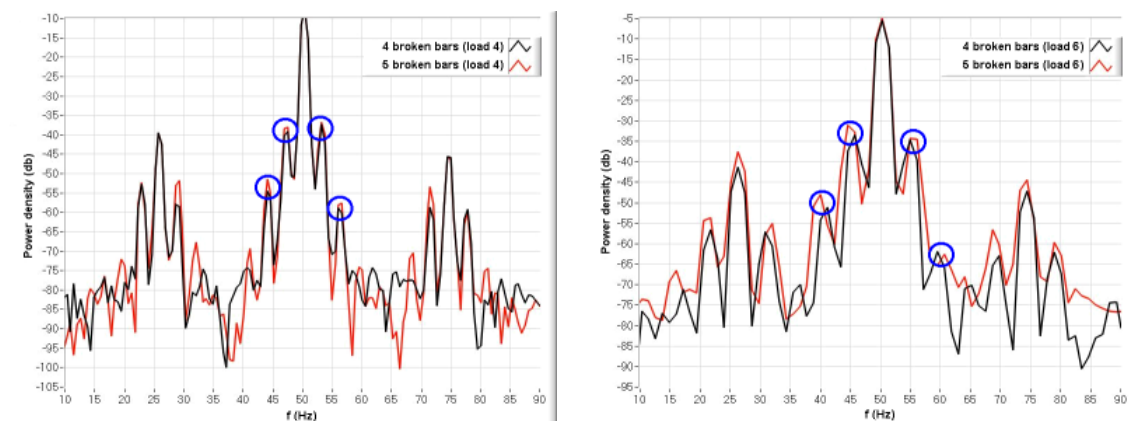
**Figure 6 – The power density of the measured line current of the motors having 4, respectively 5 broken bars, and the observed sideband frequency components**

In Fig. 6 the power density of the measured line current is given for the motor having 4, respectively 5 broken bars at the two above mentioned loads. The sideband frequency components of the power spectrum are marked with circles.

**a) Motor at load no. 4**

**b) Motor at load no. 6**

For example, for the motor having 5 broken bars at load no. 4 (65% of the rated load) the measured speed of the motor was 1455 r/min. At this speed the slip is 0,03. The corresponding sideband frequencies computed with equation (7) for  $k=1$  and  $k=2$  are: 44, 47, 53 and 56 Hz. At the rated load (no. 6) the speed is less, 1425 r/min, which means that the slip is greater, equal to 0,05. In this case the computed sideband frequencies are: 40, 45, 55 and 60 Hz.

As it can be seen, all the expected sideband frequency harmonics can be observed in the figures. Thus the above presented theory of the slip frequency sidebands is proved by measurements.

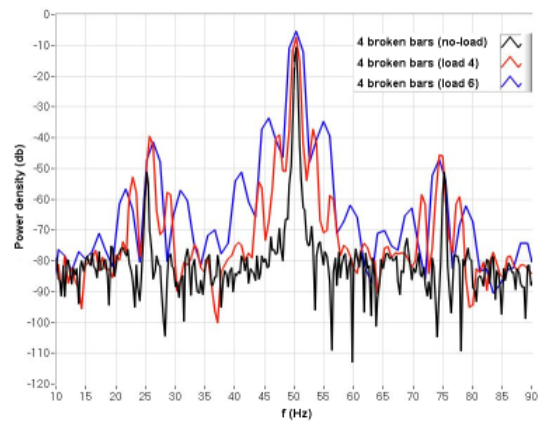
**Figure 7 – Comparative power densities of the measured line current**

These sideband frequencies are function of the slip, so they are changing with the speed (implicitly with the load). This phenomenon can be clearly observed from Fig. 7, where the power density of the measured currents for the motor having 4 broken bars are plotted for three different cases. As it can be seen, as the load is increased, the magnitude of the sideband frequency components is also increasing.
